ENVIRONMENTAL ENDURANCE TESTING OF AN  
ELASTOMERIC PITCH CHANGE BEARING

Lord Kinematics

Army Air Mobility Research and Development  
Laboratory

**USAAMRDL TECHNICAL REPORT 72-73**

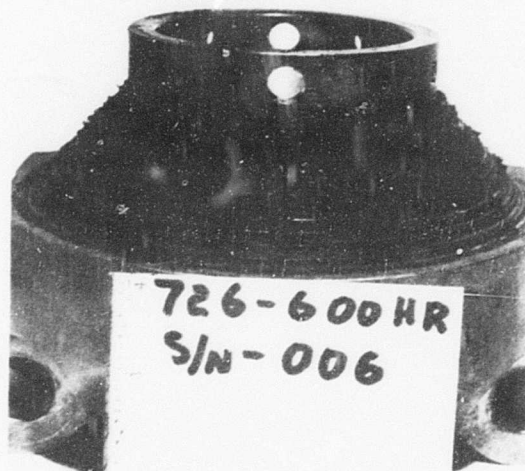
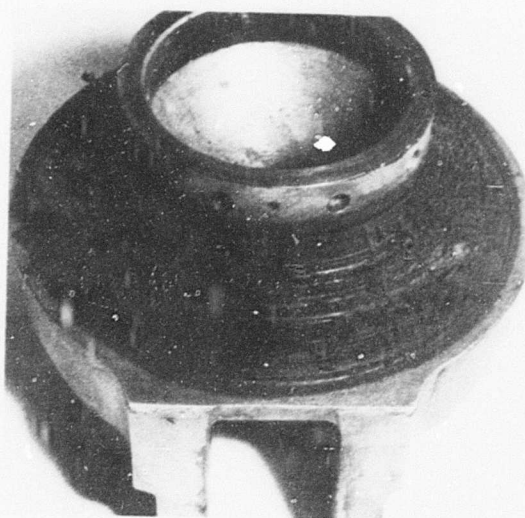
Figure 47. Test Sample 5  
(S/N 006) at Zero  
Hours.

Figure 48. Test Sample 5  
(S/N 006) at 200  
Hours.

Figure 49. Test Sample 5  
(S/N 006) at 400  
Hours.

Figure 50. Test Sample 5  
(S/N 006) at 500  
Hours.

Figure 51. Test Sample 5  
(S/N 006) at 600  
Hours.

Figure 52. Test Sample 5  
(S/N 006) at 800  
Hours.

Figure 53. Inboard View of Test Sample 5  
(S/N 006) at 1,000 Hours.

Figure 54. Outboard View of Test Sample 5  
(S/N 006) at 1,000 Hours.

Figure 55. Test Sample 5  
(S/N 006) at 1200  
Hours.

Figure 56. Test Sample 5  
(S/N 006) at 1200 Hours,  
Rotated 90 Degrees.

Figure 57. Inboard View of Test Sample 5 (S/N 006) at 1400 Hours.

Figure 58. Outboard View of Test Sample 5 (S/N 006) at 1400 Hours.

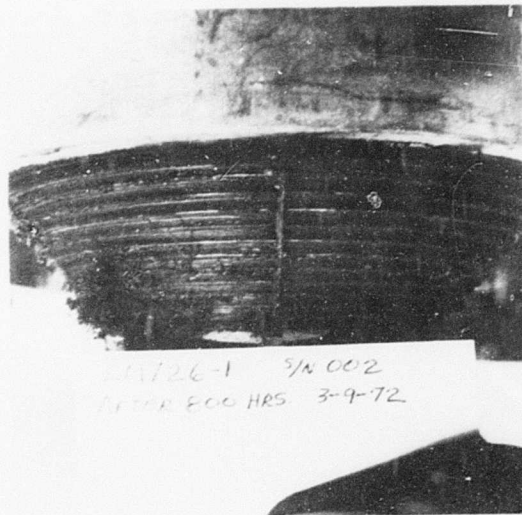
The "hair-like" abrasion typical of the early failure stages is shown in Figure 59. This is a view of test sample 2 looking at 90 degrees to the radial load. Test sample 3 is shown in the sand and dust chamber in Figure 60. Its appearance when cleaned was similar to the remaining samples.

Figure 59. Abrasion of Test Sample 2 (S/N 002) at 800 Hours.

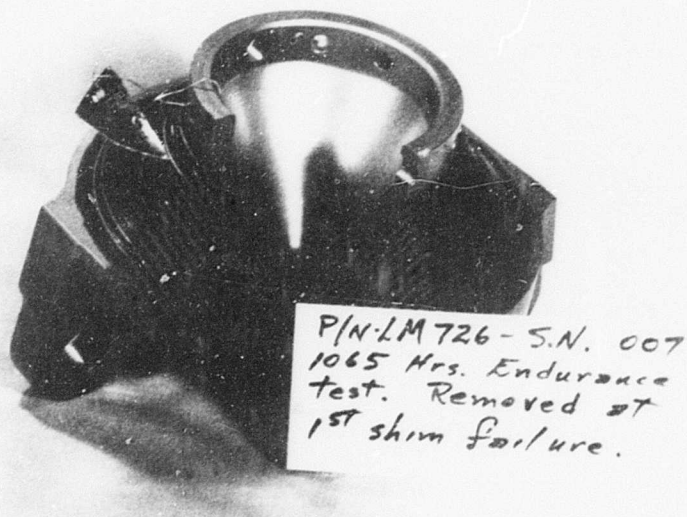
Figure 62. Sectioned View of Test Sample 6 (S/N 007) After Failure at 1065 Hours.

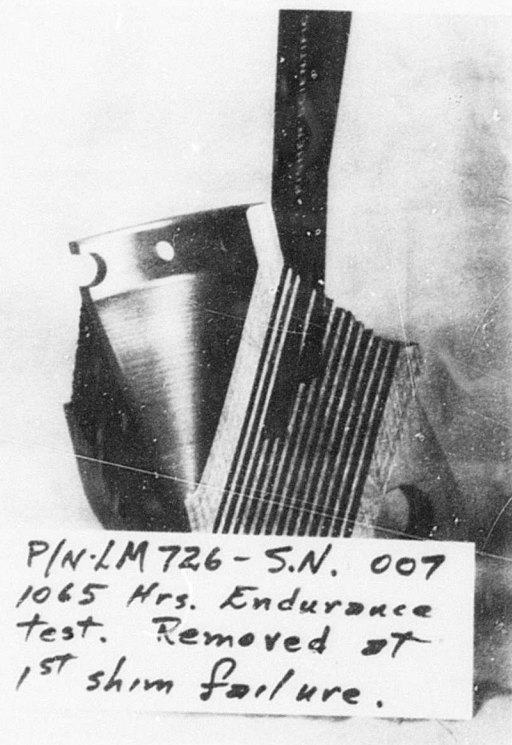
Figure 63. Test Sample 6 Showing Depth of Elastomer Loss.

Test sample 3 after failure at 800 hours is shown in Figure 61. Failure was a shearing of the elastomer in section one resulting in a complete separation of the inner member. At this point in the endurance test, deterioration was primarily in the inner six sections. A sectioned view of test sample 6, in Figure 62, illustrates the elastomer sections voids and the cracked shim. Figure 63 clearly illustrates the voids in sections one and five.
